*Energy Efficiency Consulting Services and Solutions*

*First Homes*

*1530 3<sup>rd</sup> St NE*

1. Hybrid Water Heater
  2. HRV Operational & Maintenance Signage
  3. Furnace Duct Updates
    - Return air
  4. Ventilation Updates
    - Bath Exhaust
    - Kitchen Hood Exhaust
    - Dryer Vent
  5. Rim Joist Insulation
- 
-

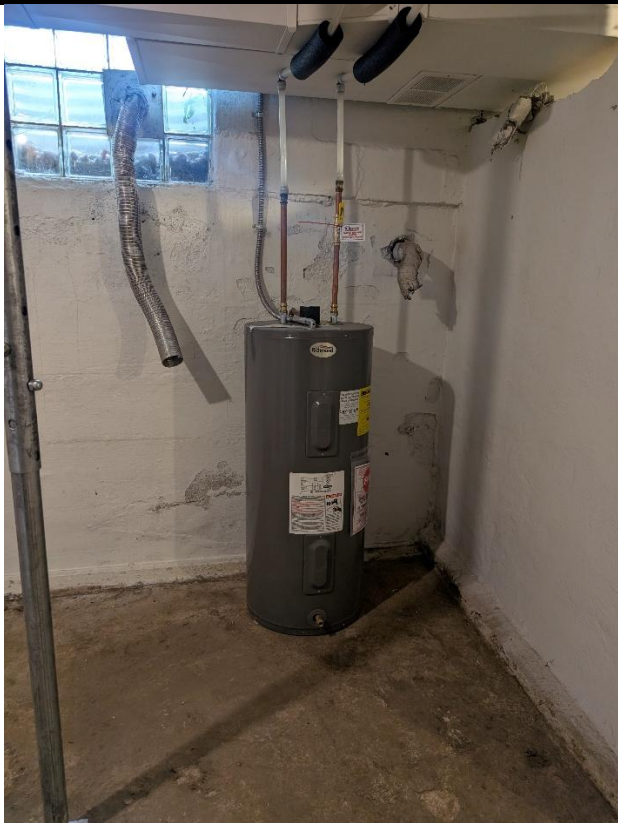
Water Heater, 40 gallon, electric 1 years old

## Clothes dryer flex duct is substandard

Electric water heater and clothes dryer flex duct

1. Hybrid Water Heater (ASHP, air-source-heat-pump)
  - Hybrid water heater operates dehumidifier (ASHP) during the spring/summer/fall and operates electric resistance during the winter
  - Damp basement is an ideal application

Clothes Dryer Vent  
Replace flex duct with rigid duct

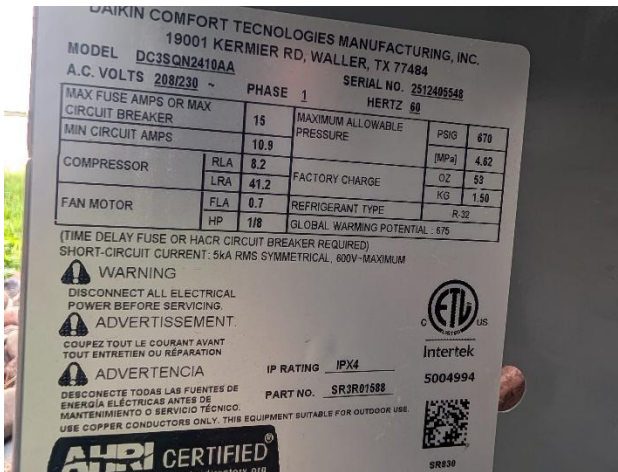
- Return air duct system is deficient

AC, 2-ton 1 year old

Furnace and central AC 2025-vintage

3. Furnace Duct Updates
  - Fabricate one (1) additional return register in the hallway
    - 7-inch duct, baseboard wall register
  - Eliminate two (2) wild return registers located in the basement
