*Energy Efficiency Consulting Services and Solutions*

***First Homes***

**2724 12<sup>th</sup> Ave NW**

1. Abandoned Exhaust Hood Removal (basement)
  2. Ventilation Updates
    - Bath Exhaust
    - Kitchen Hood Exhaust
    - Dryer Vent
  3. Rim Joist Insulation
  4. Basement Daylight Windows
  5. Entry Doors
  6. Foundation Tuck Point
  7. Mold Mitigation & Attic Insulation
- 
-

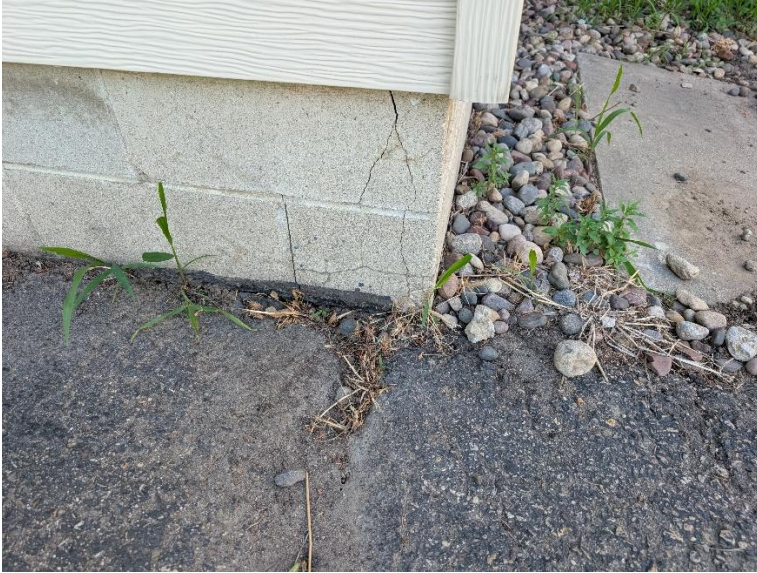
- Attic (blown) R40
  - Mold mitigation will require complete removal, claim existing R0
- Sidewall R11
- Basement rim joist R0
- Basement foundation R10
  - Minor cracks in the corners
- Windows Double-pane
- Entry Doors Good/fair condition

Foundation cracks

- Minor foundation repair (cracks are visible interior and exterior)

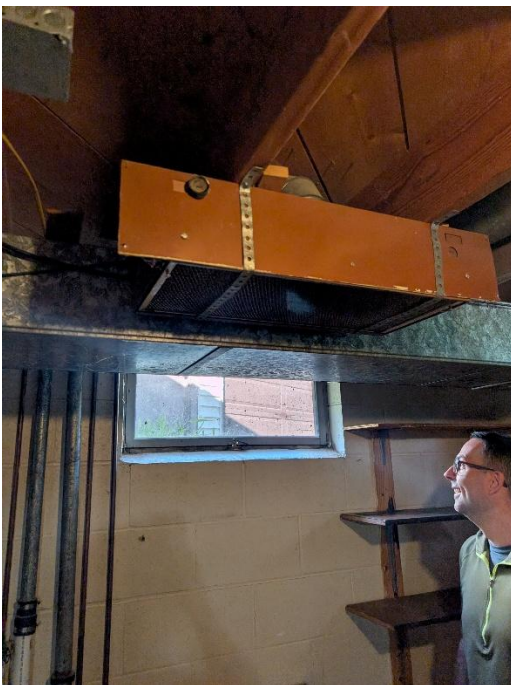
Abandoned exhaust hood

- Remove exhaust hood located in the basement and air seal rim joist penetration
